NASA CR-159600
VOLUME 1 OF 2
AIRESEARCH 21-3213-1

MATERIALS FOR ADVANCED TURBINE ENGINES

PROJECT COMPLETION REPORT PROJECT 2

ABRADABLE COMPRESSOR AND TURBINE SEALS

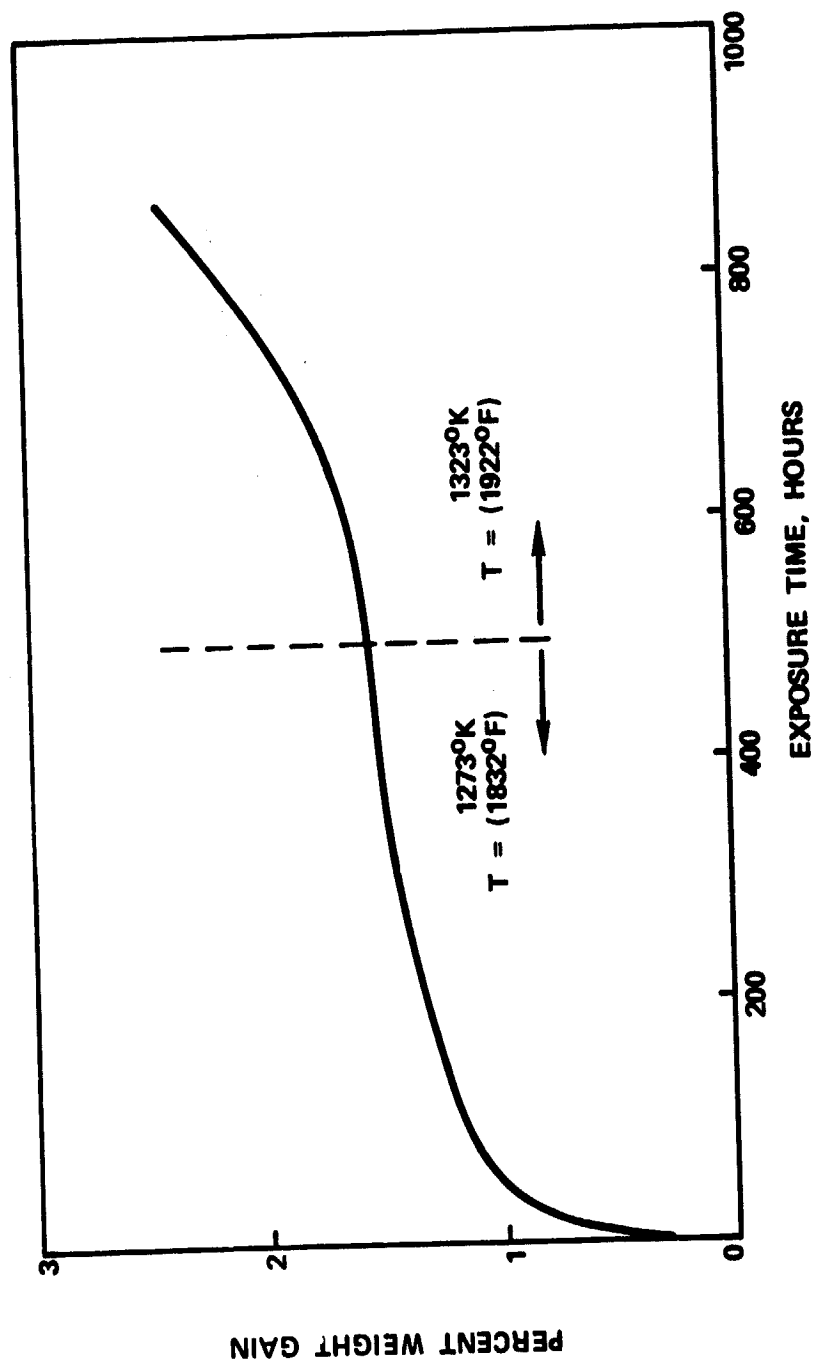
of 1323°K (1922°F) where failure occurred at the abradable-substrate interface (bond joint) after 370 hours (as shown in Figure 23). The braze became completely oxidized at these conditions and the weight gain of the brazed piece is illustrated in Figure 24.

Figure 24. Oxidation Behavior of a Brazen High-Pressure Turbine Shroud Segment of the UCAR AB-4 Abradable Material Brazed with LM Microbraz

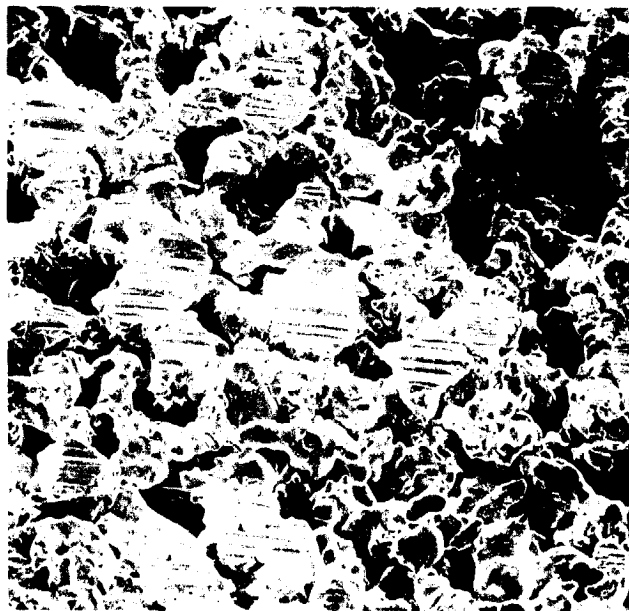
a. UCAR AB-1 - A layer of nickel was deposited on four INCONEL 718 shoes as a diffusion barrier, and then UCAR AB-1 was direct-sintered to the shoe. Two of the shoes were coated with 8.27-MPa (1200-psi) tensile strength material while the other two were coated with a higher strength material that was then oxidized in air at 1005°K (1350°F) for 24 hours down to approximately 8.27-MPa (1200-psi) strength. This pretest oxidation was meant to simulate long-time engine tested parts. The shoes were tested as described above. X-ray analysis of the rubbed surfaces in a scanning electron microscope (SEM) did not show evidence of titanium-alloy blade transfer, and the impeller blades did not exhibit wear. All four shoes had similar rub surfaces with no apparent difference between oxidized and non-oxidized material. The abrasibility of the AB-1 material was judged "good" based on the appearance of the rubbed surface and the absence of titanium-alloy blade-metal transfer. The typical appearance of the AB-1 shoes after testing is shown in Figure 32.

Figure 32. Typical Appearance of the UCAR AB-1 [8.27-MPa (1200-psi)] High-Pressure Compressor Test Shoes After One Hour of Engine Testing

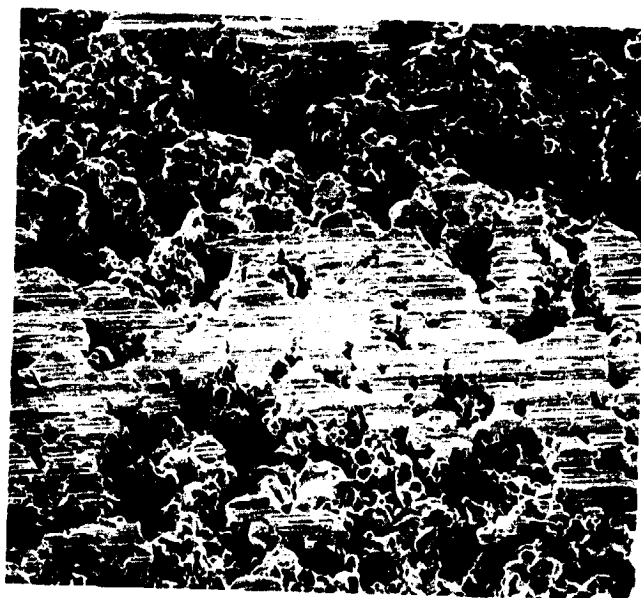
b. UCAR AB-3 - Two strength levels of UCAR AB-3--5.52 MPa (800 psi) and 7.58 MPa (1100 psi)--were applied by direct-sintering in a manner similar to AB-1, and then engine tested as described previously. Examination of the rubbed test shoes showed that some titanium-alloy had been transferred from the impeller blades, although the impeller did not show measurable wear. The two strength levels of AB-3 gave comparable results. The appearance of the rub surface was similar to that of AB-1, but due to the titanium pickup, the overall abrasability of AB-3 was rated below AB-1. Optical and SEM photographs of the rubbed surfaces of the two strength-level materials are shown in Figures 33 and 34.

Figure 33. Typical Appearance of the UCAR AB-3 [5.52-MPa (800-psi)] High-Pressure Compressor Test Shoes After One Hour of Engine Testing

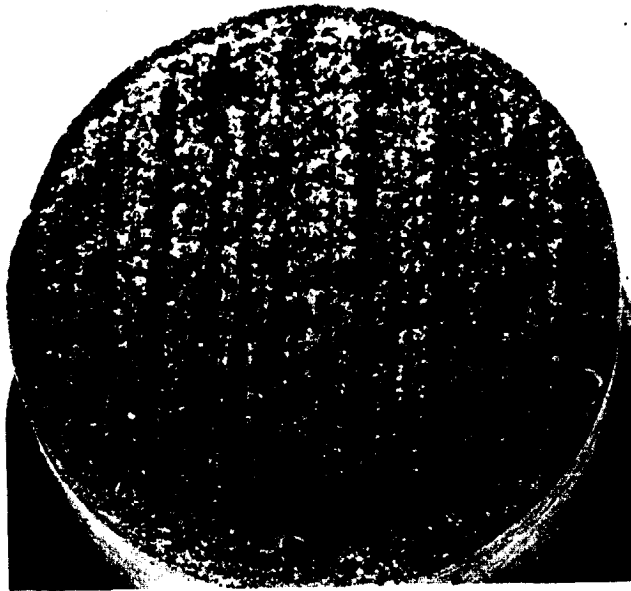
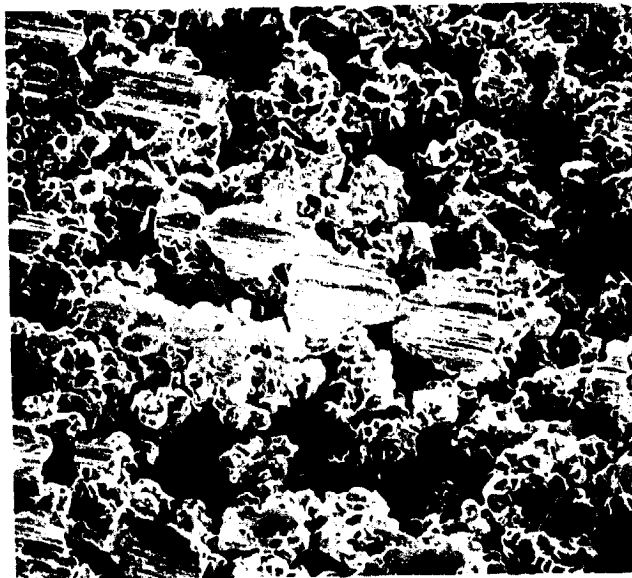
Figure 34. Typical Appearance of UCAR AB-3 [7.59-MPa (1100-psi)] High-Pressure Compressor Test Shoes After One Hour of Engine Testing

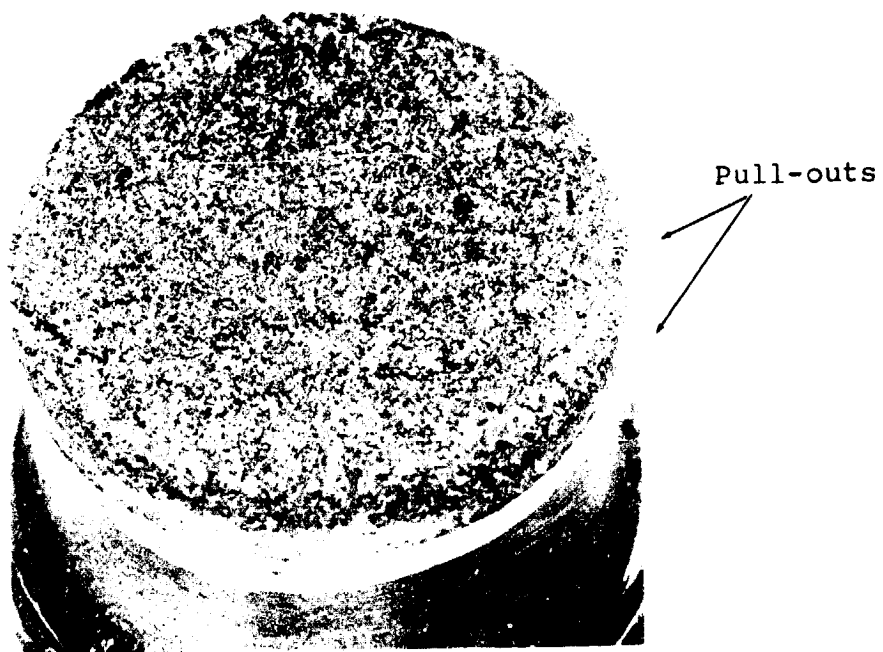
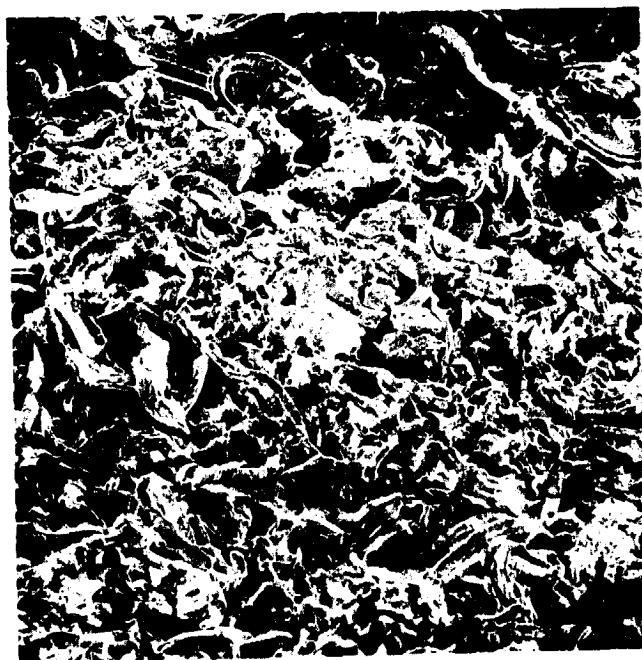
c. Feltmetal 501 - This material was brazed to the test shoe surface using LM Microbraz (AMS 4777 Type) alloy. The braze material "wicked" approximately 0.38 mm (0.015 inch) into the fiber-metal structure, but this was not considered detrimental to the test. Evaluation after the standard test of the shoe in the engine showed a slight amount of "pull-out" on the surface. X-ray examination of the rub surface did not disclose the presence of titanium, and impeller wear was not detected. The abrasability of this material was down-graded to a "fair" rating due to the pull-outs. Optical and SEM photographs of the rub surface of the Feltmetal 501 are shown in Figure 35.

Figure 35. Typical Appearance of the Feltmetal 501 High-Pressure Compressor Test Shoes after One Hour of Engine Testing

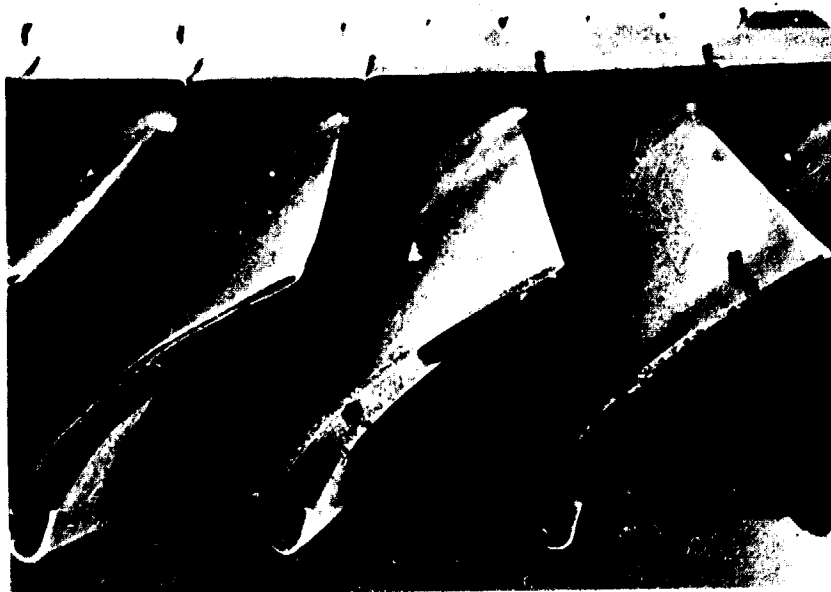
assembly did not affect the abrasability evaluation, and heat generation and carryover from one segment to the next was not detected. The ratio of the maximum amount of material removed from the shroud assembly (maximum inside diameter) to the diameter reduction in the rotor was calculated as 4:1. This defined the wear ratio for the 16.35-MPa (2400-psi) strength-level material in the Build 1 test since this hard material removed blade-tip material during smearing. No other wear ratios were determined. The pretest and post-test appearance of the rotor blade tips are shown in Figure 39.

Figure 39. High-Pressure Turbine Rotor Blade Tips Before and After 23.5 Hours of the First Interim Engine Test, Build 1

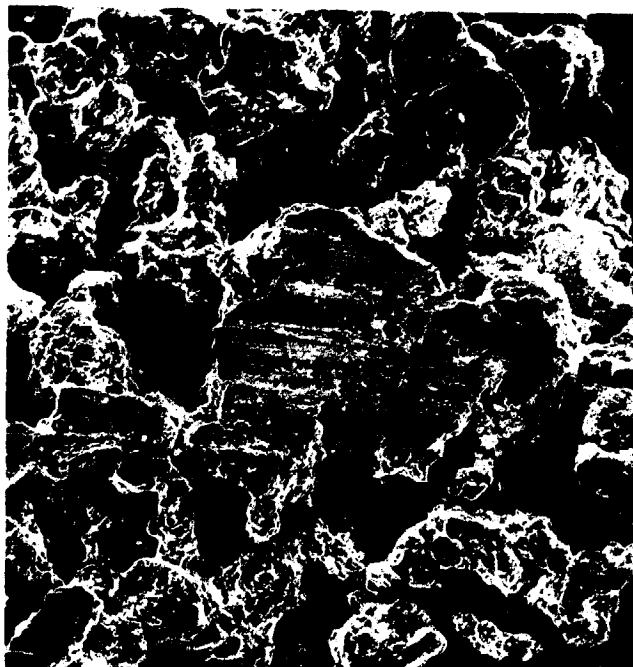
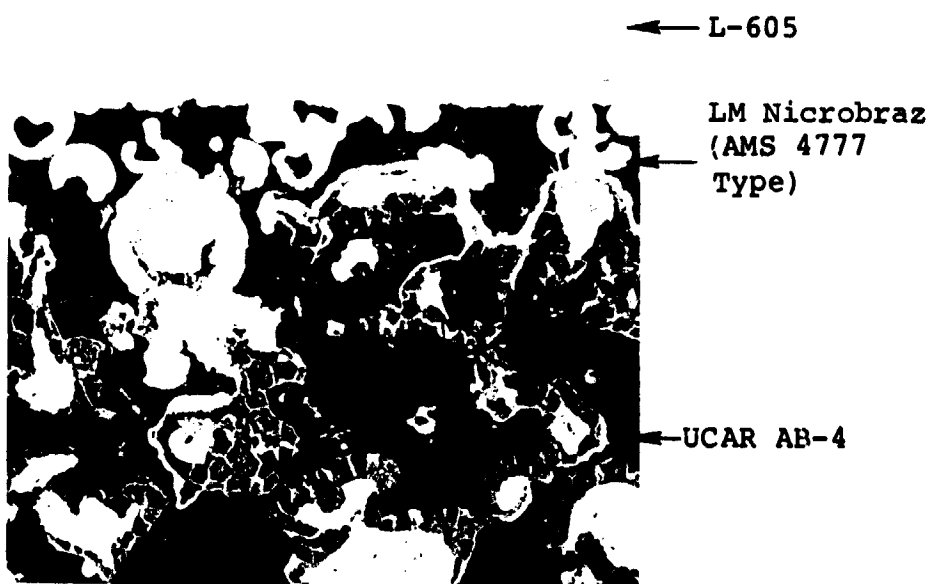
b. UCAR AB-4, 13.74-MPa (2000-psi) strength level-
Segment 60C, 13.74-MPa (2000-psi) material, was worn to a depth of between 0.203 and 0.432 mm (0.008 and 0.017 inch). Examination of these areas under the SEM disclosed the typical abrading shown in Figure 41 with traces of blade alloy found in the wear regions. Also shown in Figure 41 is the etched microstructure from a cross section taken in the segment center. Note the braze alloy flow, and that the bond integrity between the L-605 alloy substrate, and the AB-4 abrasable was maintained during testing. Based on the appearance of the rub areas and the absence of heat generation, the material was given a "good" rating for abrasability, and there was no evidence of gas erosion.

Figure 41. High-Pressure Turbine Shroud Segment 60c [UCAR AB-4, 13.74 MPa (2000 psi)] After 23.5 Hours of the First Interim Engine Test, Build 1. Typical Wear Region and Cross-Section Microstructure are Shown (Mag.: 100X)

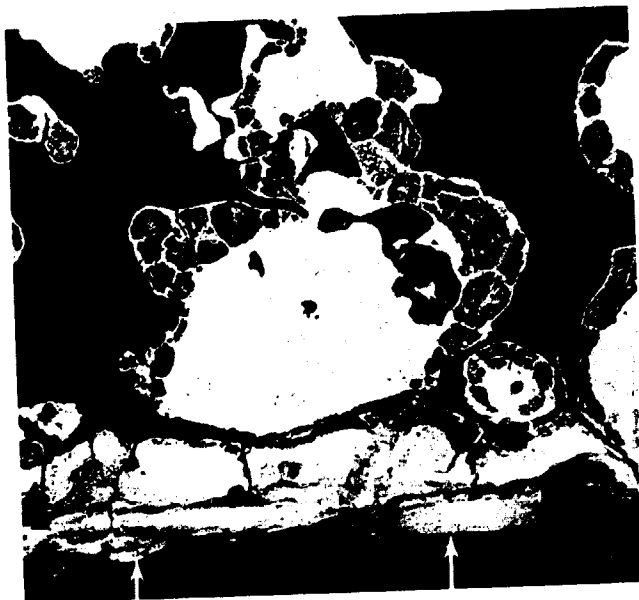
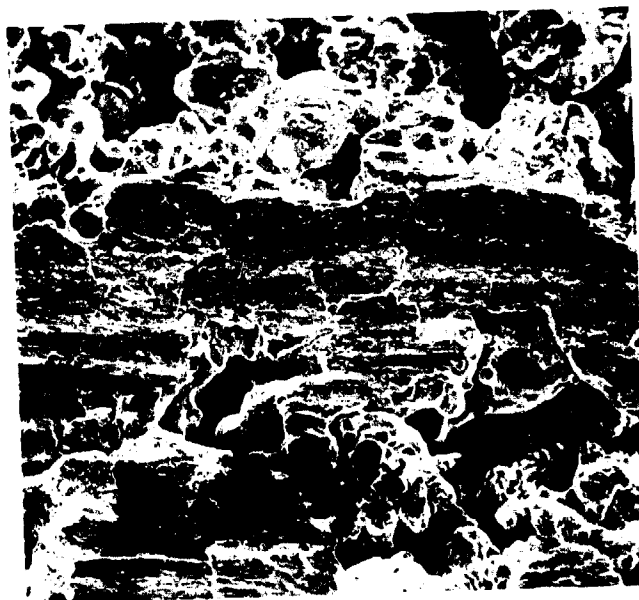
c. UCAR AB-4, 16.35 MPa (2400-psi) strength level-
Segment 75B, 16.35 MPa (2400 psi) material, exhibited 0.457 mm (0.018 inch) of wear in the deepest groove and a large smear area. Figure 42 presents the smeared surface as examined under the optical microscope and the SEM. X-ray analysis disclosed that the surface of the smear region was

Figure 42. High-Pressure Turbine Shroud Segment 75B [UCAR AB-4, 16.35 MPa (2400 psi)] After 23.5 Hours of the First Interim Engine Test, Build 1

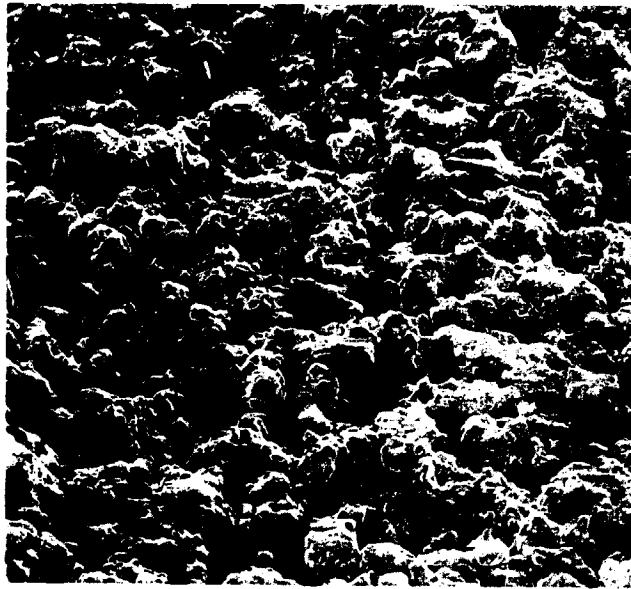
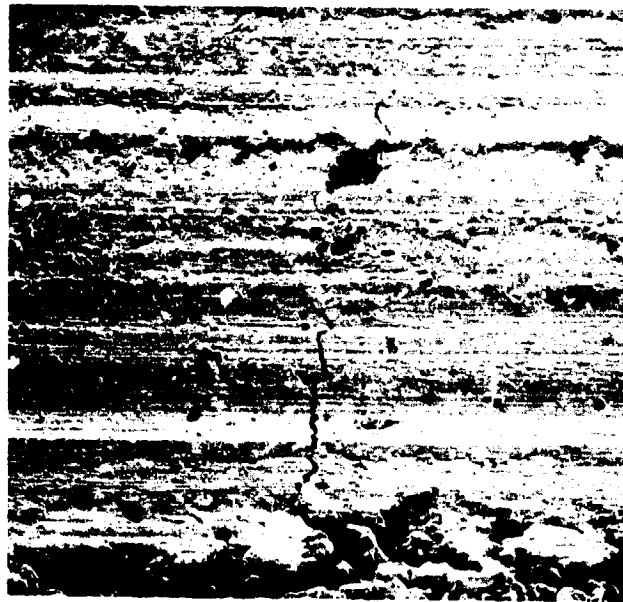
Visual observations after completion of 23.5 hours of testing on Build 1 indicated that the material had a tendency to smear and crush instead of fracture at particle boundaries. The depth of the grooves produced by the turbine blade knife edges ranged from zero (no contact) at the 12:00 o'clock position to 0.229 mm (0.009 inch) near the 6:00 o'clock position. The appearance of the rubbed surfaces as compared to the non-rubbed surfaces, as seen on photomicrographs from the scanning electron microscope, are shown in Figure 43. A typical cross-section microstructure, shown in Figure 44, illustrates the good braze quality, and the thin UCAR coating (proprietary) surrounding the abrasable particles. The calculated wear ratio for the UCAR AB-2 in the first-stage turbine is approximately 1:1. The abrasability was rated "fair" because of the materials crushing (instead of fracture) characteristic.

Figure 43. First-Stage Low-Pressure Turbine Abradable Shroud [UCAR AB-2, 8.96 MPa (1300 psi)] After 23.5 Hours of the First Interim Engine Test. Build 1 (Mag.: 50X)

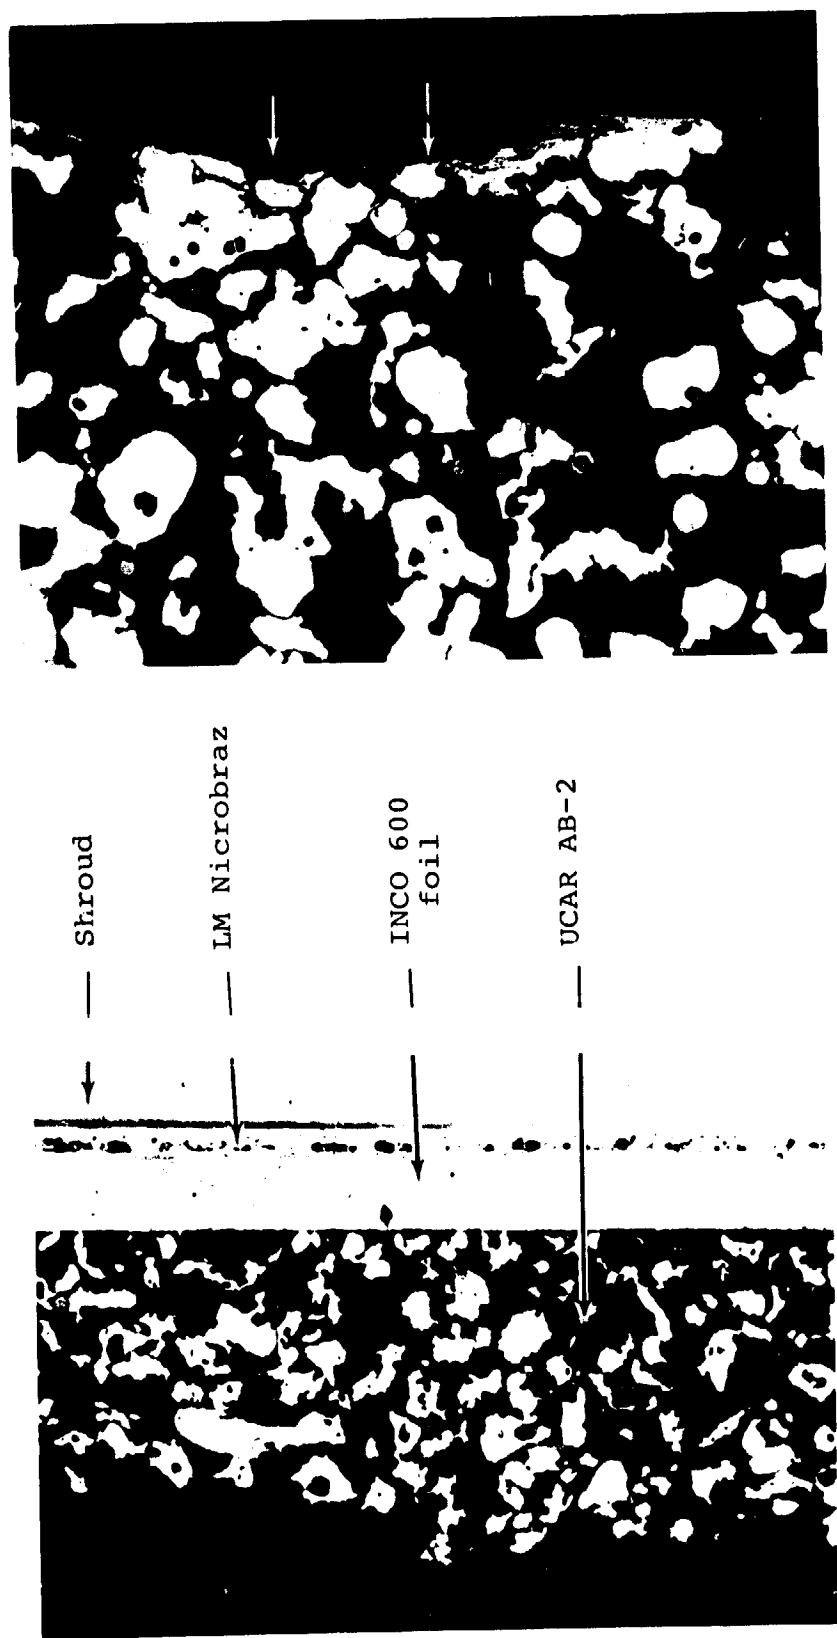
(b) After 23.5 Hours of the First Interim Engine Test, Build 1. (Smeared, Unetched) (Mag.: 100X)

Figure 44. Typical Microstructure of the First-Stage Low-Pressure Turbine Shroud [UCAR AB-2, 8.96 MPa (1300 psi)]

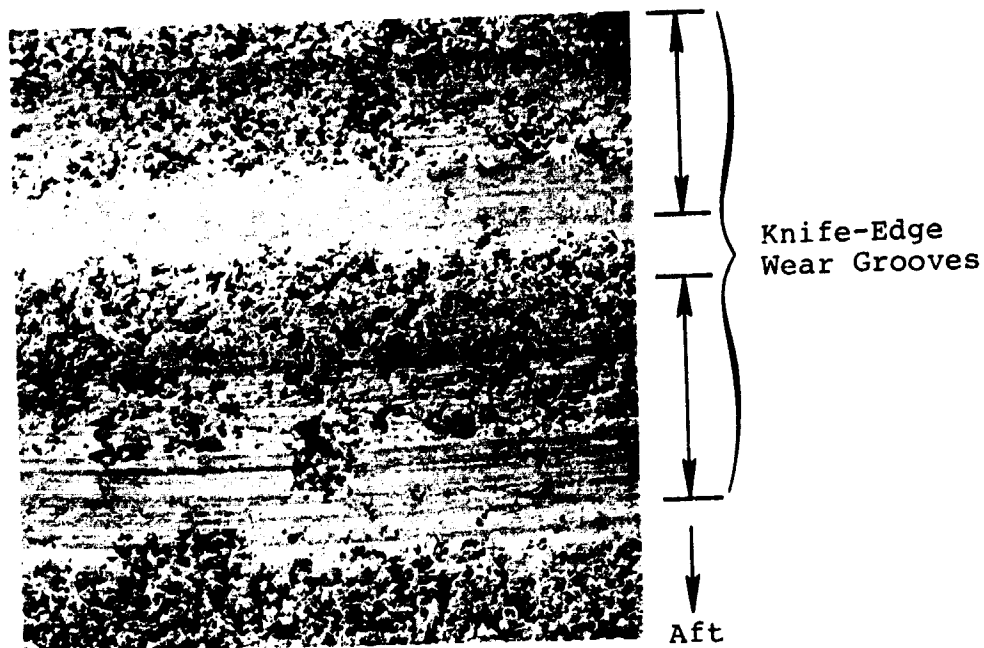
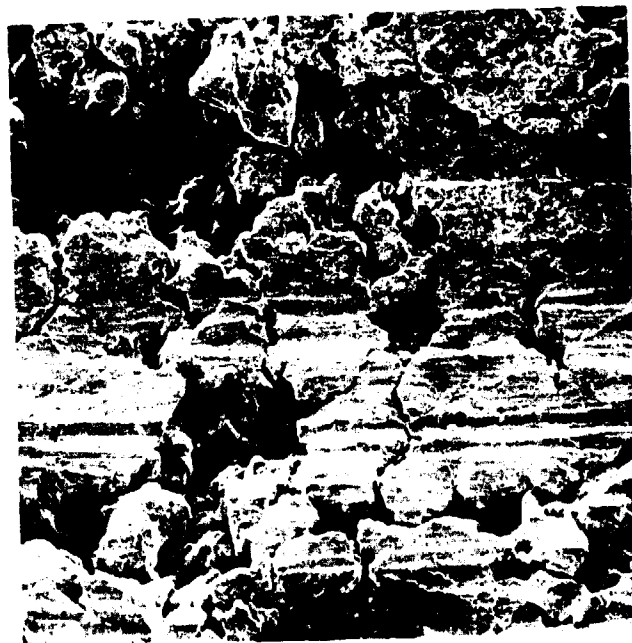
During the Build 1 test (23.5 hours), a 360-degree rub was produced in the UCAR AB-2 material on the second-stage shroud with the wear depth ranging from 0.127 to 0.254 mm (0.005 to 0.010 inch). The appearance of the rub was similar to that observed in the first-stage except that only a portion of the wear grooves were smeared as shown by the SEM examination (see Figure 45). The surface condition of the lightly smeared region is also shown in this figure. Traces of blade alloy were detected on the rubbed surfaces. The wear ratio was calculated to be 10:1, considerably better than the 1:1 observed for the same material on the first-stage. This improvement was the result of very little blade material being removed due to the lower temperature, and therefore higher strength of the blade alloy. The overall abrasability in this application was rated "fair-to-good".

Figure 45. Second-Stage Low-Pressure Turbine Abradable Shroud
[UCAR AB-2, 8.96 MPa (1300 psi)] After 23.5 Hours
of the First Interim Engine Test, Build 1

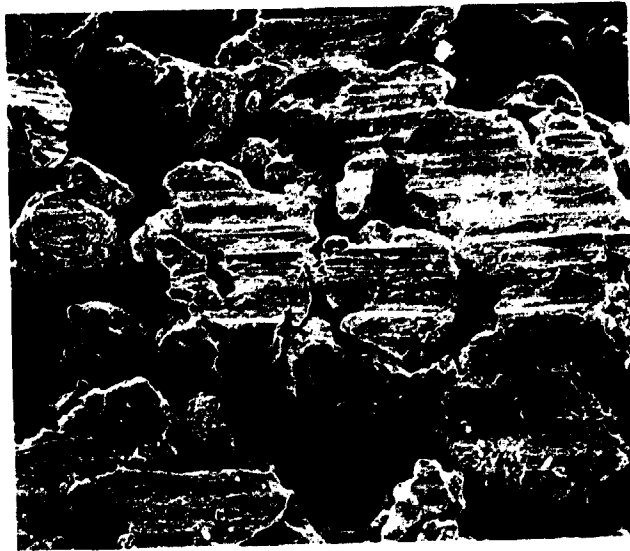
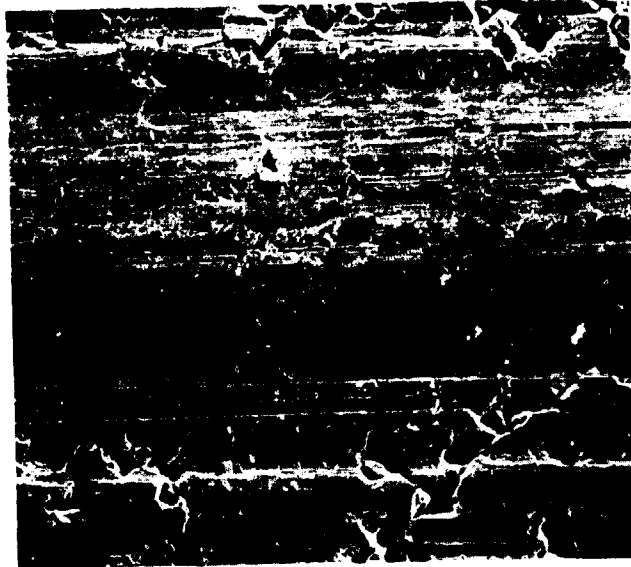
The appearance of the rub on the 8.96-MPa (1300-psi) strength material was similar to that observed on the first and second stages. The heavy smear was again predominant with small regions of light rub. The wear regions of the 5.52-MPa (800-psi) strength material are shown in Figure 47 where typical areas of heavy and light smearing are shown. These are similar to comparable regions of the 8.96-MPa (1300-psi) strength material on the first and second stages. X-ray analysis of both strength levels of AB-2 detected traces of blade metal in the heavily rubbed regions. The overall abrasibility of the 8.96-MPa (1300-psi) strength AB-2 was rated "fair" to "good" while the 5.52-MPa (800-psi) material was rated good.

Figure 47. Third-Stage Low-Pressure Turbine Abradable Shroud
[UCAR AB-1, 5.52 MPa (800 psi)] After 23.5 Hours
of the First Interim Engine Test, Build 1

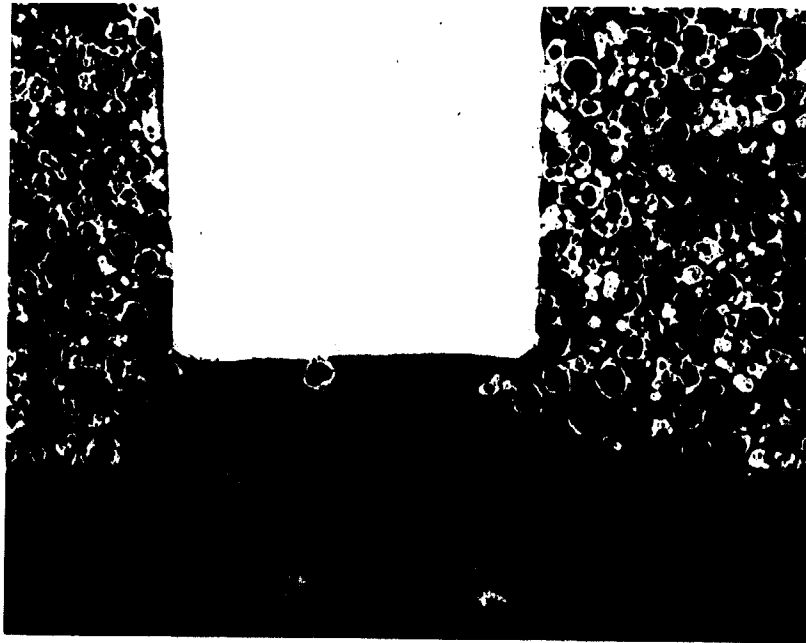
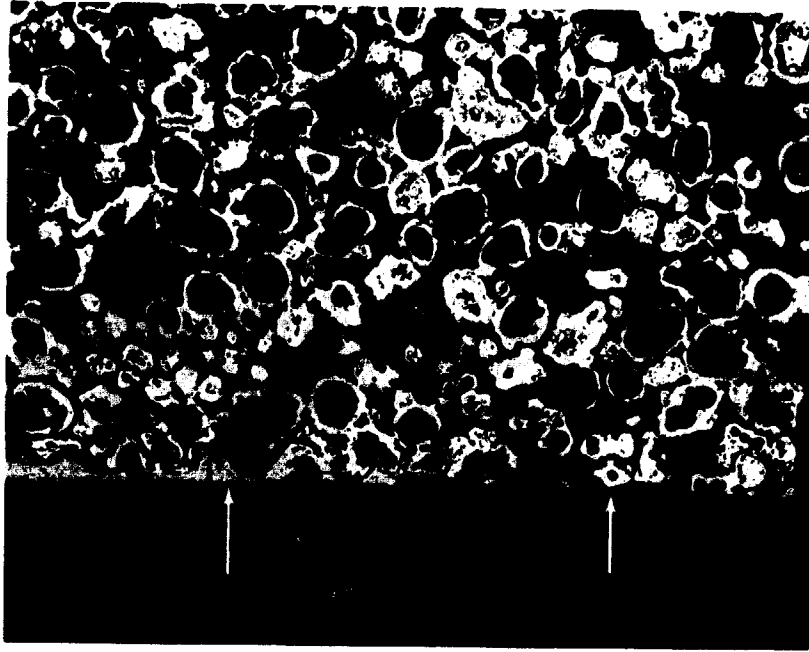
Figure 52. High-Pressure Turbine Shroud Segment BR-1 (Bradelloy 500) Showing Microstructures Near the Surfaces of an Unrubbed and a Rubbed Region After the First Interim Engine Test, Build 2

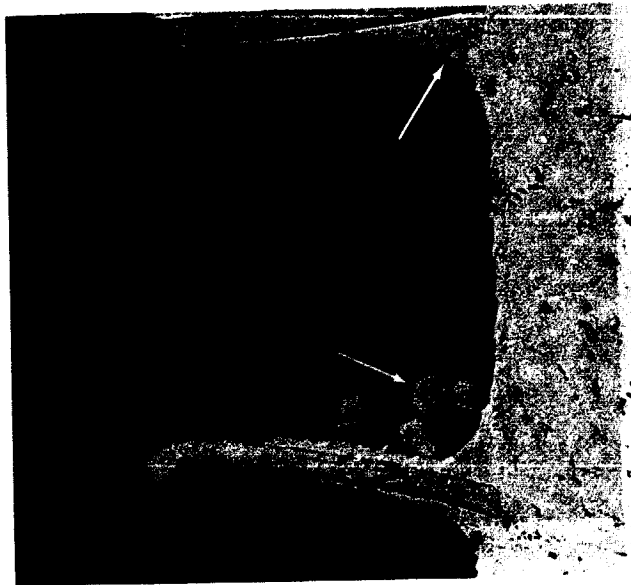
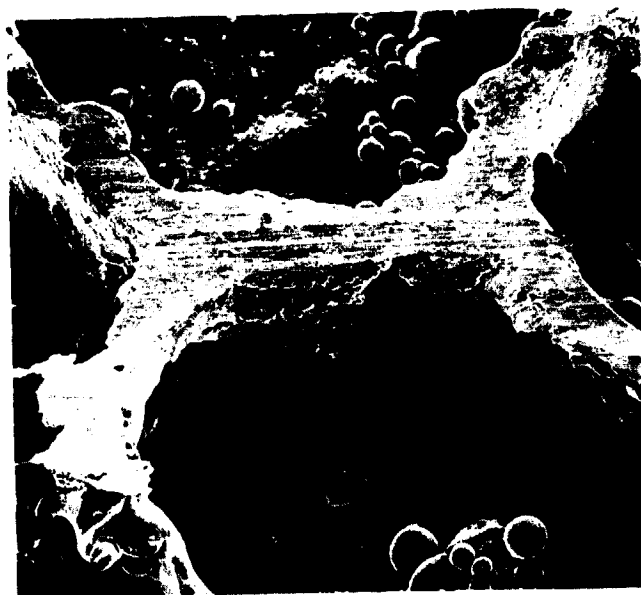
The wear depths of the Hastelloy-X Honeycomb ranged from no contact to 0.1778 mm (0.007 inch) near the AB-2/Honeycomb joint. Optical and SEM views of the Honeycomb after engine testing are shown in Figure 53. It is evident from this figure that excessive braze alloy was utilized (note the unflowed braze powder and wicking on the foil). The knife-edge rub produced smearing and folding of the foils, which can also be seen in Figure 53. A wear ratio for the honeycomb could not be calculated, since the rotor-blade wear was influenced by the harder UCAR AB-2. Blade-alloy transfer was not evident on the honeycomb. The overall abrasability of the Hastelloy-X Honeycomb was rated "good".

(a) Optical Cross-Section View
 (Note Braze Wicking, Excess Braze, and Folding of Foils)

Figure 53. Appearance of the Hastelloy-X Honeycomb First-Stage Low-Pressure Turbine Shroud After the First Interim Engine Test, Build 2 (Mag.: 50X)

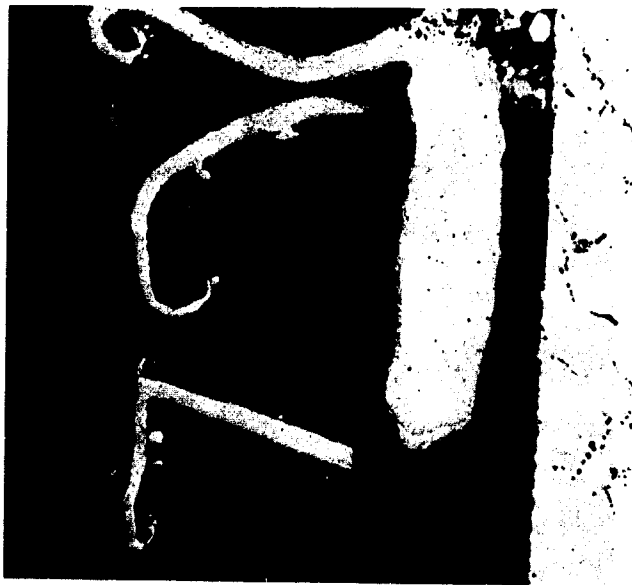
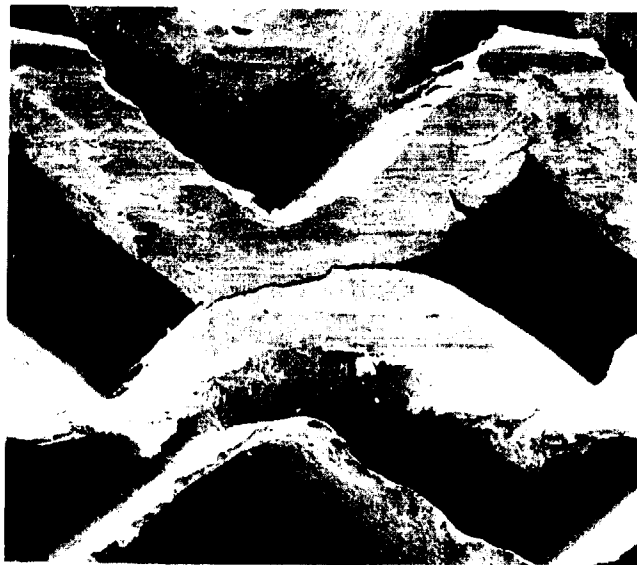
Approximately 180 degrees of this shroud was rubbed by the rotor-blade knife edges during the Build 2 test. The wear depth was measured at 0.3048 mm (0.012 inch) on the aft groove, and 0.2794 mm (0.011 inch) on the forward groove at the point of severest rub. Enlarged views of this material after testing are shown in Figure 54. It appeared that crushing and smearing occurred with very little heat generation. SEM examination disclosed a trace of the Alloy 713LC blade alloy in the smeared regions. The wear ratio was calculated at 23:1, which is considered excellent, and the overall abrasability was rated "good".

Figure 54. Appearance of the Solabrade Second-Stage Low-Pressure Turbine Shroud After the First Interim Engine Test, Build 2 (Mag.: 50X)

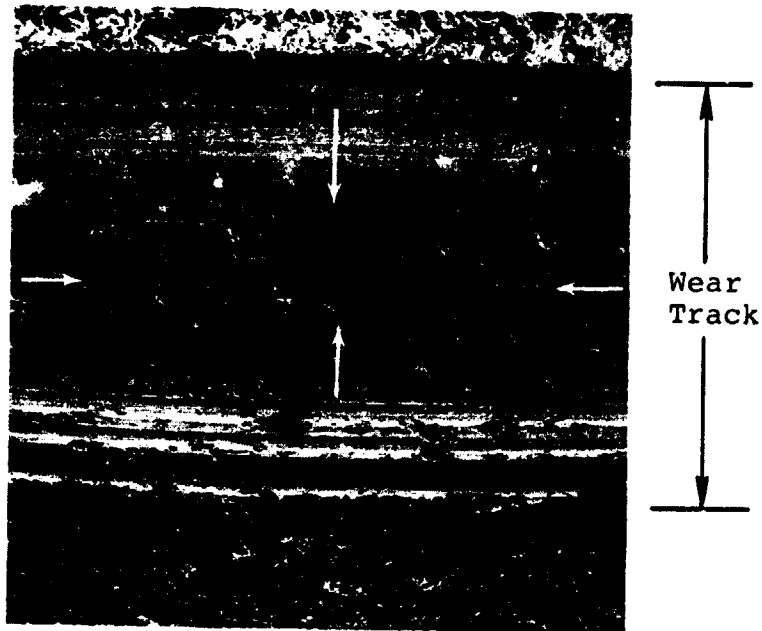
(a) SEM Image of Aft Track Rub Area (Mag.: 20X)
(Arrows Show Pull-Out Region)

(b) SEM Image of Aft Track Rub Area (Mag.: 100X)
(Heavy Smearing)

Figure 55. Appearance of the Feltmetal 522 Third-Stage Low-Pressure Turbine Shroud After the First Interim Engine Test, Build 2

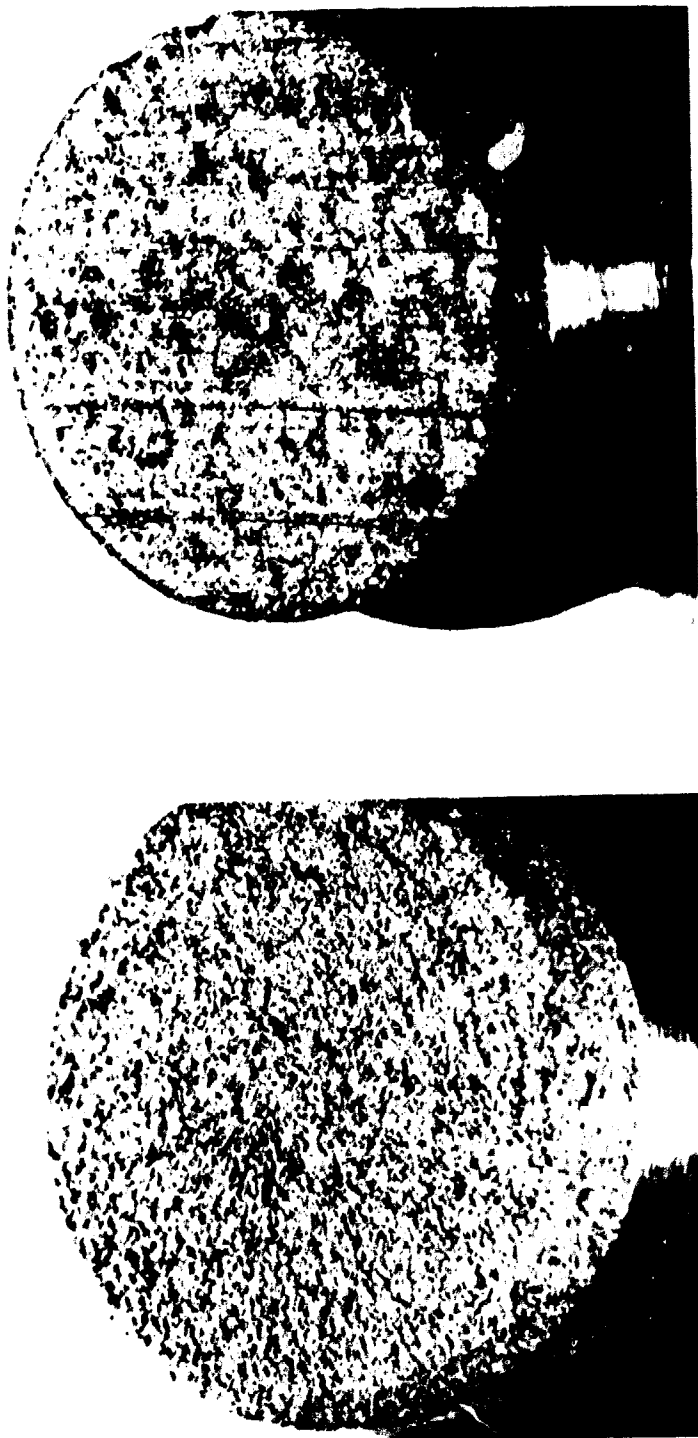
Optical View After Testing
(Arrows Indicate Pull-Outs)

Figure 56. Typical Appearance of a Feltmetal 515B High-Pressure Compressor Test Shoe Before and After One Hour of Engine Testing in the Second Interim Engine Test, Build 3 (Mag.: 7X)

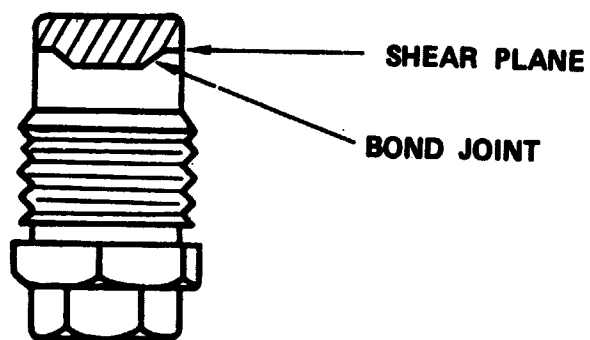
Figure 59. High-Pressure Compressor Test Shoe Showing Recessed Bond Joint

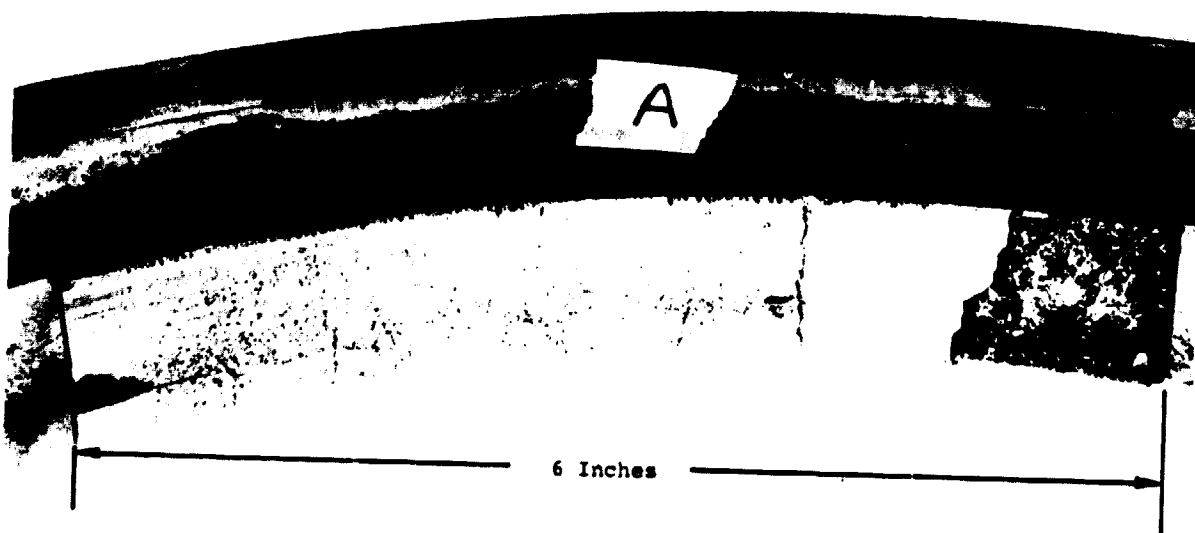
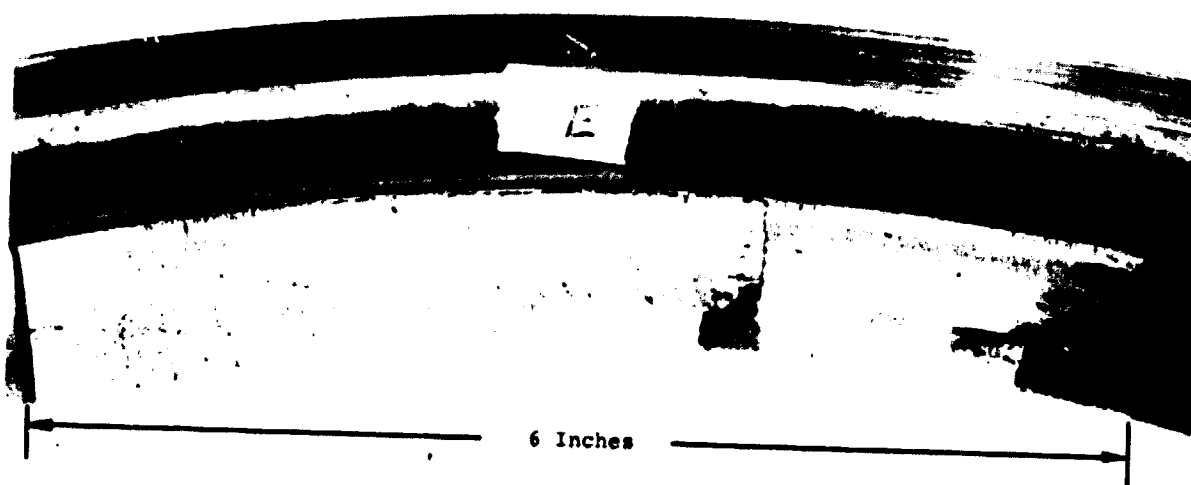
The 25-hour Build 3 test produced cracking and spalling in both of these tested shroud segments (with large pieces missing as shown in Figure 66). The cross-section microstructure presented in Figure 67 shows the layers in the sprayed composite, as well as the separation between the ceramic and fiber-metal layers after testing. This separation was believed to be caused by thermal fatigue or a difference in thermal expansion between the two material layers. The turbine rotor blade rubbed both test segments. Two magnifications of the rub surface are shown in Figure 68. X-ray analysis (in the SEM) confirmed a definite blade-metal pickup on the ceramic abradable surface. The abradability of Brunsbond composite was rated "poor" due to lack of integrity within the material and evidence of blade-metal transfer.

Figure 66. Appearance of Brunsbond Composite High-Pressure Turbine Shroud Segments After 25 Hours of the Second Interim Engine Test, Build 3

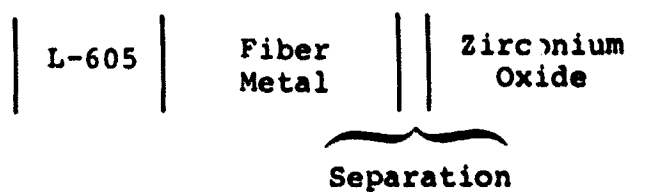
Figure 67. Cross-Section Microstructure of Brunsbond Composite
After 25 Hours of the Second Interim Engine Test,
Build 3 (Mag.: 20X)

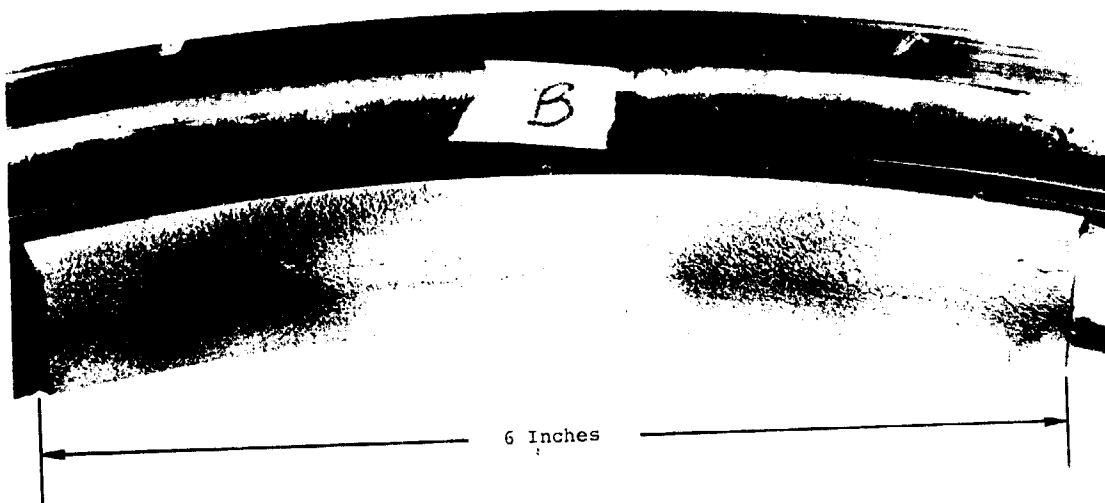
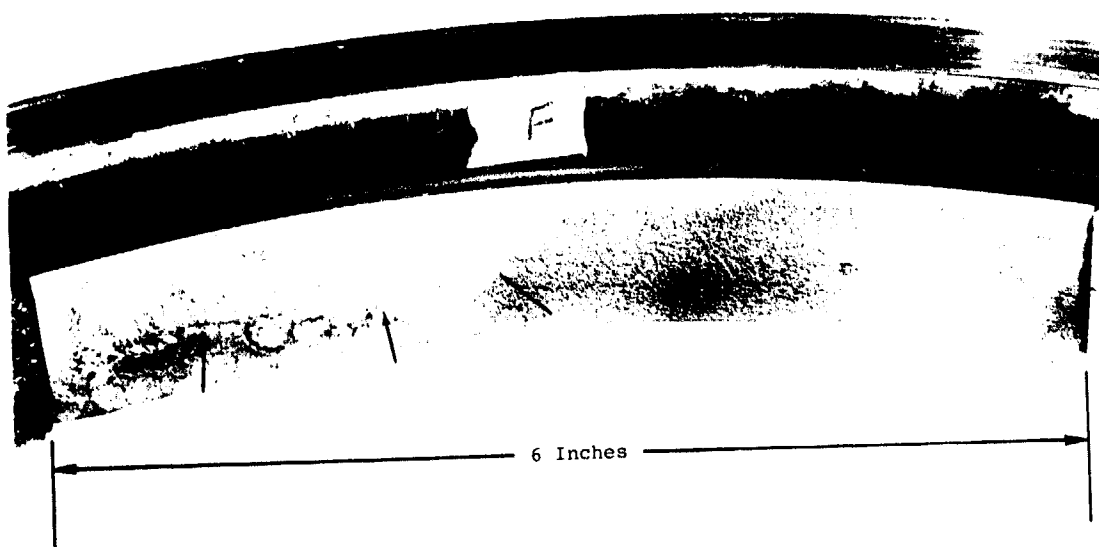
The 25 hours of testing in Build 3 of the Second Interim Engine Test produced cracking and spalling of both segments of Metco T201-10, as shown in Figure 69, similar to but not as severe as the yttria-stabilized zirconia (Brunsbond Composite). A cross-section microstructure is shown in Figure 70, which illustrates the four layers of the coating. The surface of the segments contained many small cracks, probably due to thermal fatigue. Details of these cracks can be seen on the SEM images presented in Figure 71. A rub region was not detected on the segment selected for metallogurgical evaluation, so X-ray analysis in the SEM was not accomplished. However, it is anticipated that blade-metal would be transferred to this zirconia material during a rub, as it was on the yttria-stabilized zirconia. Metco T201-10 abradable material was rated "poor" due to the cracking and spalling experienced in the engine testing.

Figure 69. Appearance of Metco T201-10 High-Pressure Turbine Shroud Segments After 25 Hours of the Second Interim Engine Test, Build 3 (Arrows Show Spalled Regions)

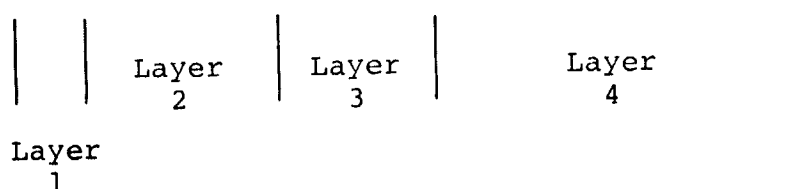
Figure 70. Cross-Section Microstructure of Metco T201-10 After
25 Hours of the Second Interim Engine Test, Build 3
(Unetched.) (Mag.: 50X)

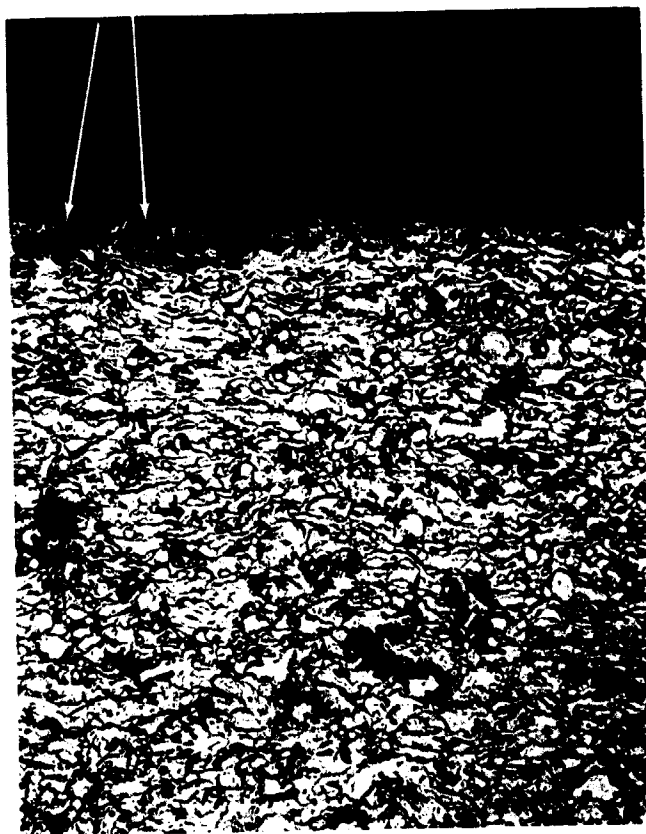
Figure 72 shows the cross-section microstructure of Metco P443-10 (dense) after engine testing exhibiting a rubbed surface and Figure 73 shows two SEM images of the rubbed region. X-ray analysis (in the SEM) revealed a deposit of blade-metal on the rubbed surface indicating material transfer. The abradability of Metco P443-10 (dense) was rated "poor" due to evidence of heat generation and blade-metal transfer.

Figure 72. Cross-Section of Metco P443-10 (Dense) After
25 Hours of the Second Interim Engine Test,
Build 3 (Unetched.) (Mag.: 50X)

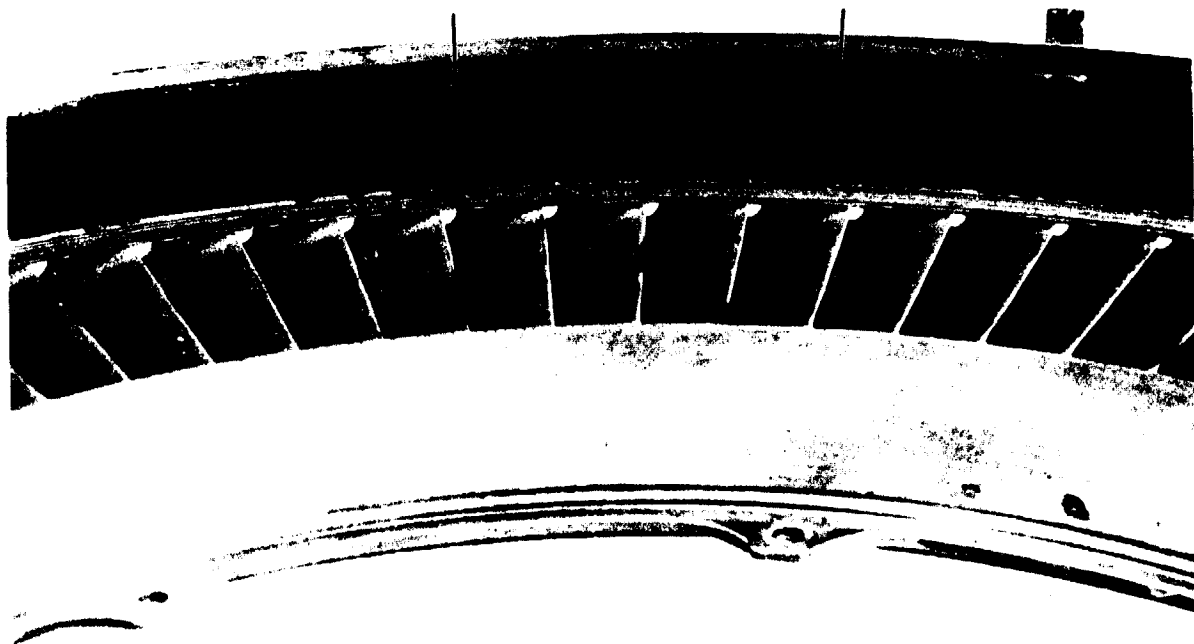
1. First-Stage Low-Pressure Turbine Shroud. The abrasible tested in the first-stage low-pressure turbine shroud in Build 4 of the Second Interim Engine Test was Metco T450-14* with a nominal composition of 4.5-percent aluminum and 95.5-percent nickel. This material was thermosprayed into the cast Alloy 713LC shroud structure using spray parameters designed to yield an open structure of moderate density. During the test of this material, blade contact occurred over approximately 180 degrees of the shroud up to a depth of 0.0762 mm (0.003 inch). Erosion of the material, however, was observed for the full 360 degrees as shown in Figure 83. The erosion appeared to be most severe between the two knife-blade edges which may indicate that particles of the coating were trapped between the knife edges, and acted as abrasives causing further erosion. Gas erosion is indicated in Figure 83 by the "rounded" corners, and the pulled-out areas of the coating outside the wear tracks. Figure 84 shows the appearance of the wear track and the cross-section microstructure. The wear track was smeared and a crushing of the abrasible structure was noted. As determined by SEM analysis, blade-metal had been transferred to the surface of the coating. The microstructure showed large open regions that may explain the susceptibility of this material to erosion. With this type of structure, clusters of the abrasible material may be held loosely together. These clusters are then easily broken loose during engine testing. The abrasibility of this material was rated "poor" based on the rub characteristics and the extensive erosion.

Region of most severe erosion

Figure 83. Appearance of Metco T450-14 First-Stage Low-Pressure Turbine Shroud After 25 Hours of the Second Interim Engine Test, Build 4 (Mag.: Approx. 1/2X)
